# ONSITE PHOTO DOCUMENTATION

Hyperion Builders

INSPECTION DATE  
May 23, 2025

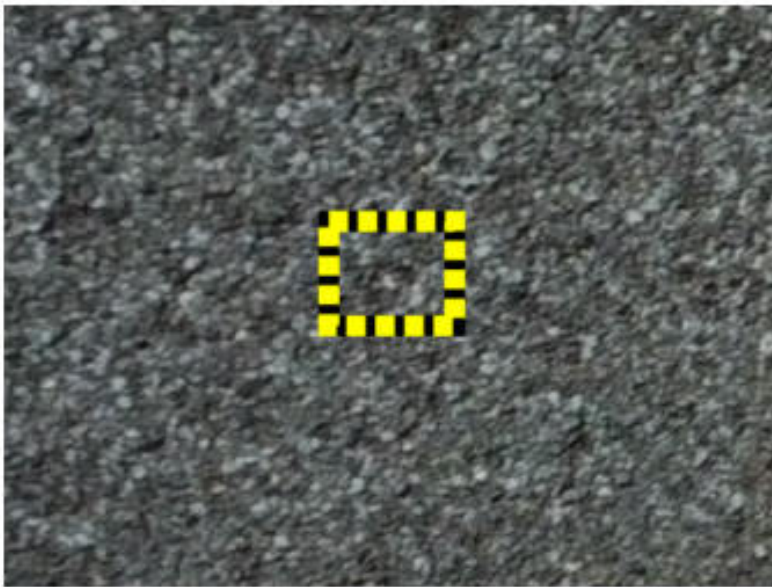
DETAILED VIEW - HAIL #1

Damage consistent with hail strikes

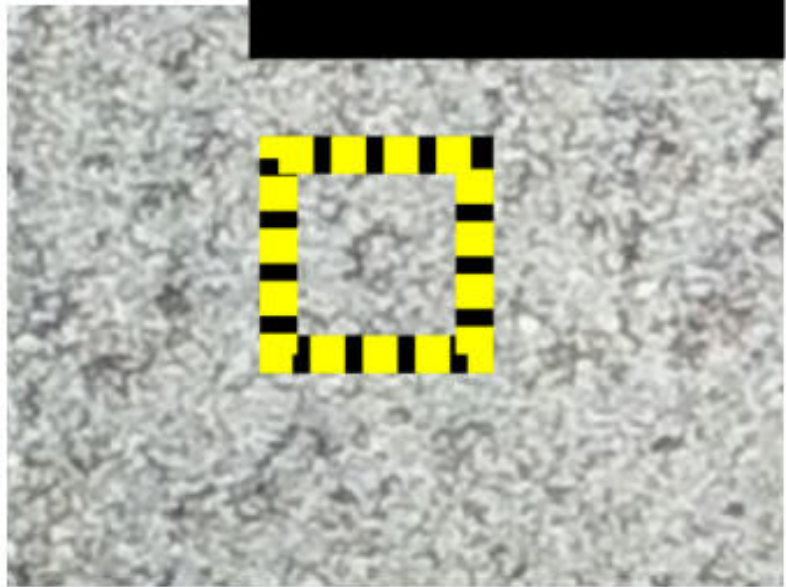
DETAILED VIEW - HAIL #2

Damage consistent with hail strikes

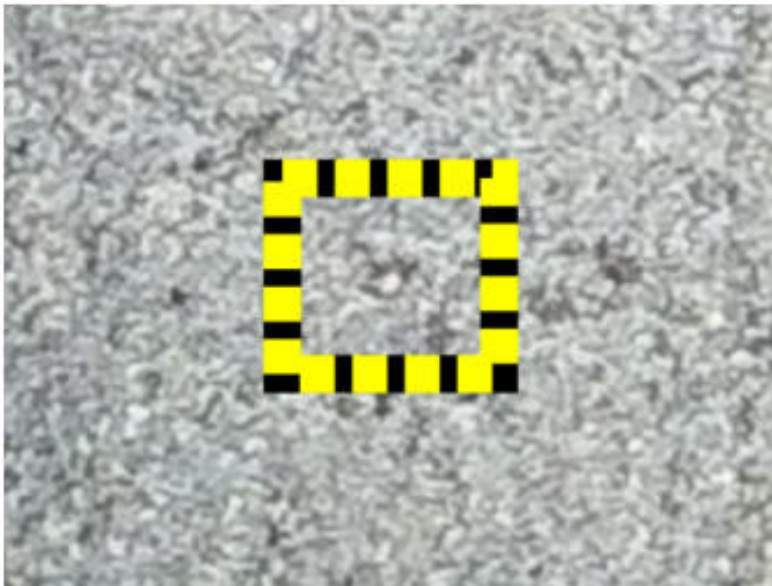
DETAILED VIEW - HAIL #3

Damage consistent with hail strikes

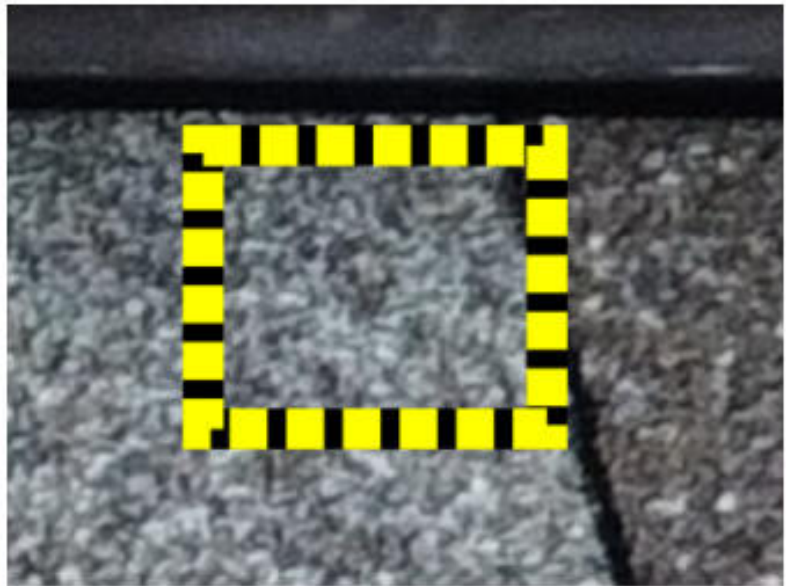
DETAILED VIEW - HAIL #4

Damage consistent with hail strikes

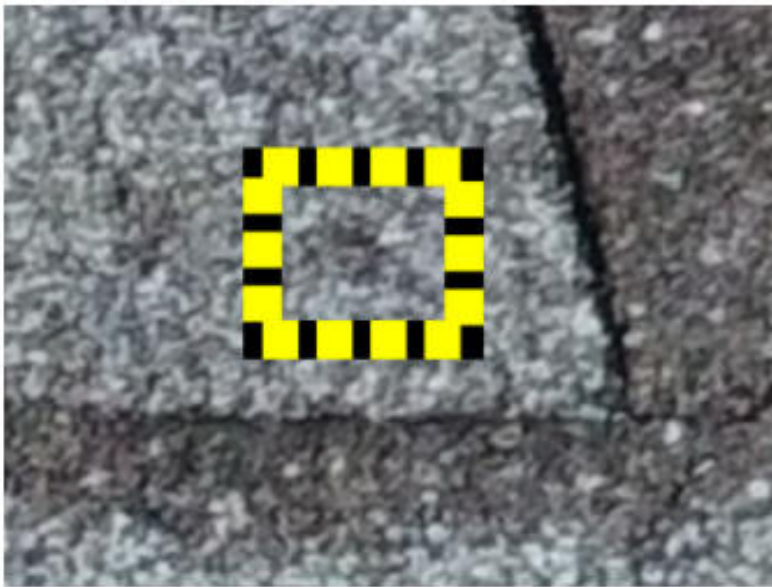
DETAILED VIEW - HAIL #5

Damage consistent with hail strikes

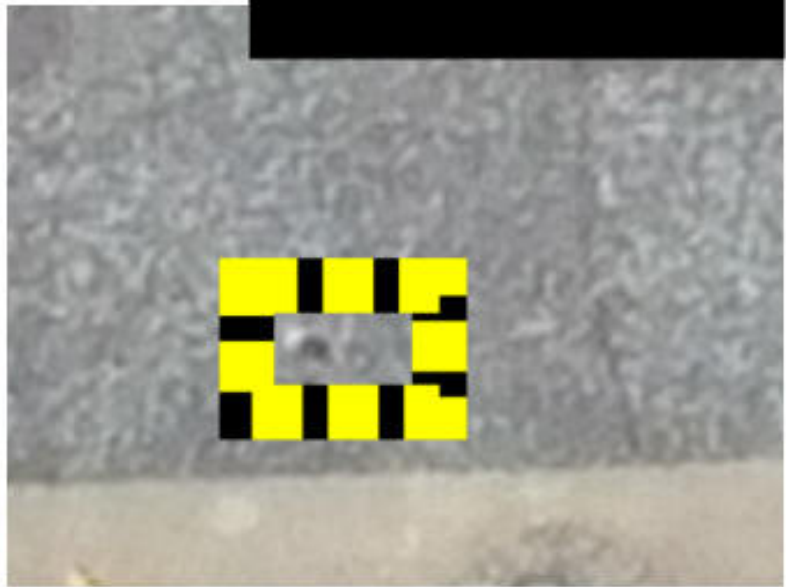
DETAILED VIEW - HAIL #6

Damage consistent with hail strikes

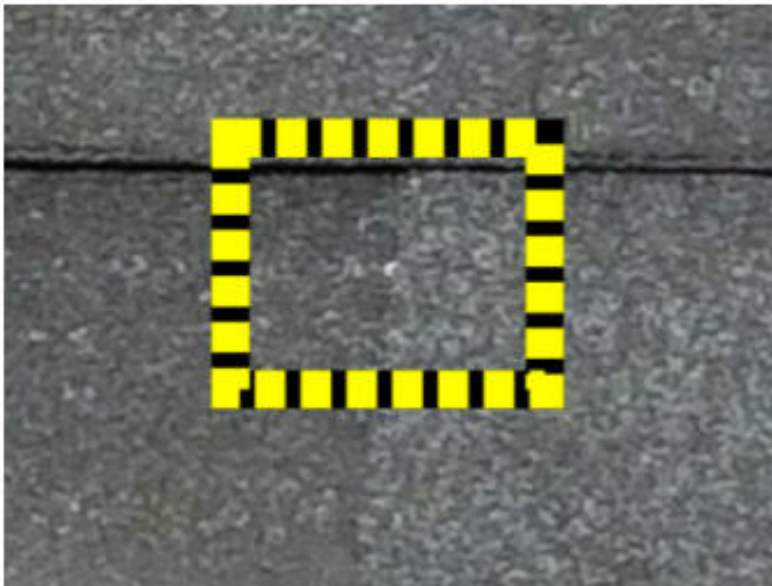
DETAILED VIEW - HAIL #7

Damage consistent with hail strikes

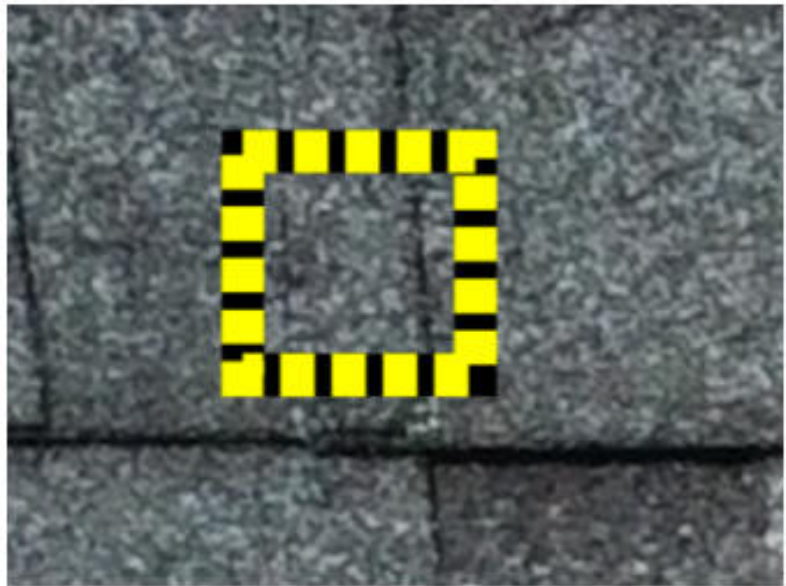
DETAILED VIEW - HAIL #8

Damage consistent with hail strikes

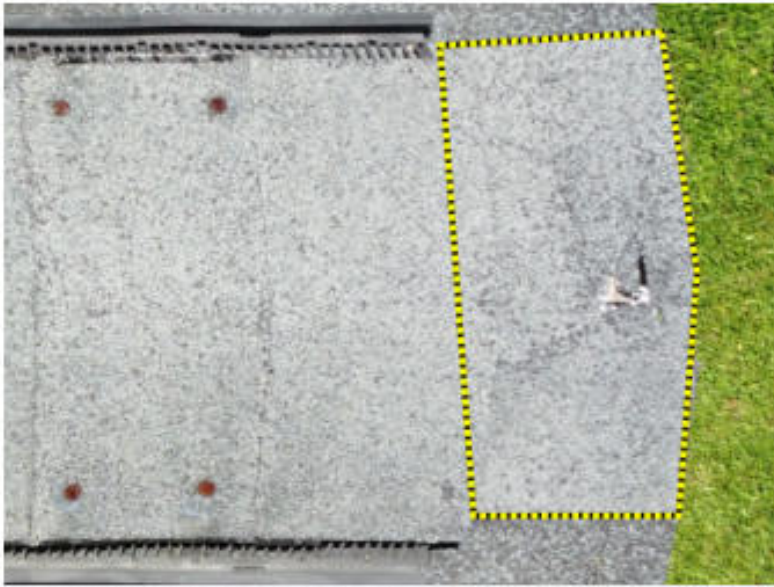
DETAILED VIEW - WIND #1

Damage consistent with wind stress; Broken shingle

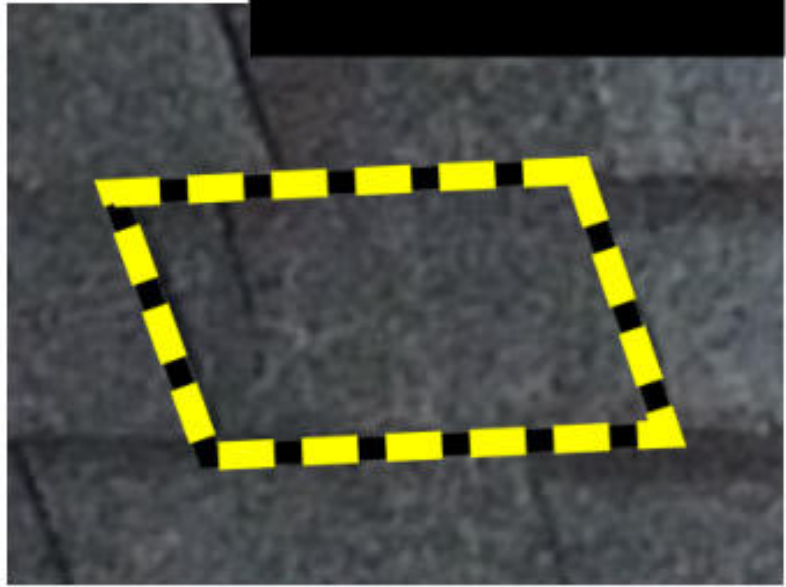
DETAILED VIEW - WIND #2

Damage consistent with wind stress; Broken shingle

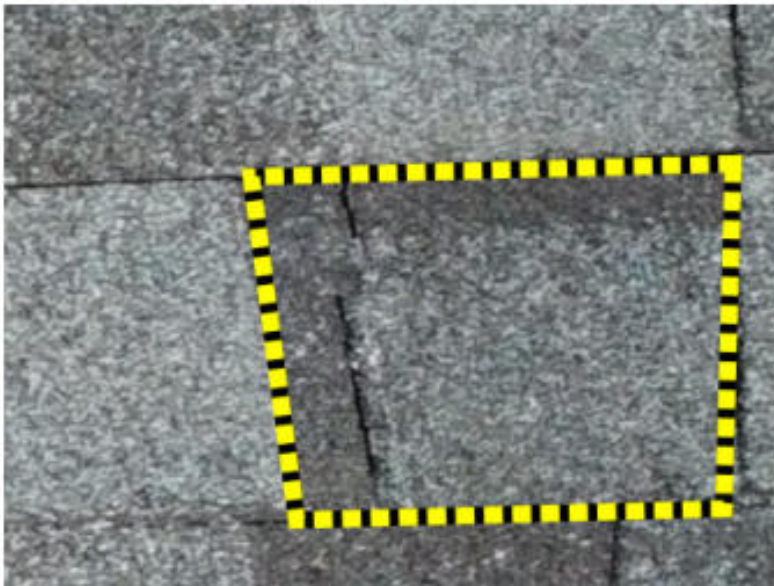
DETAILED VIEW - WIND #3

Damage consistent with wind stress; Broken shingle

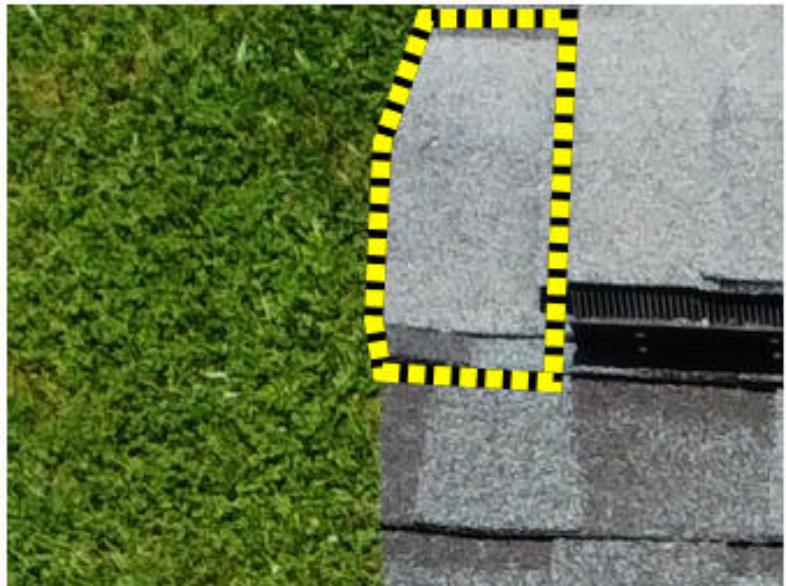
DETAILED VIEW - WIND #4

Damage consistent with wind stress; Curled shingle

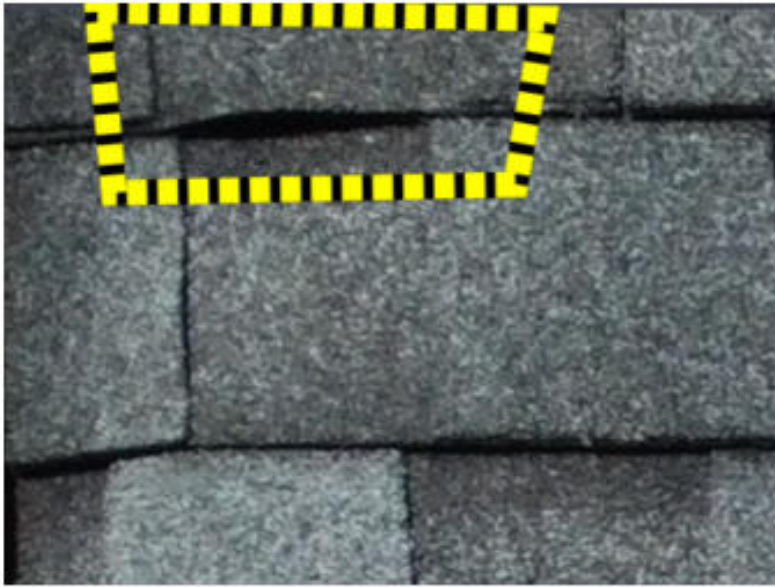
DETAILED VIEW - WIND #5

Damage consistent with wind stress; Bulked shingle

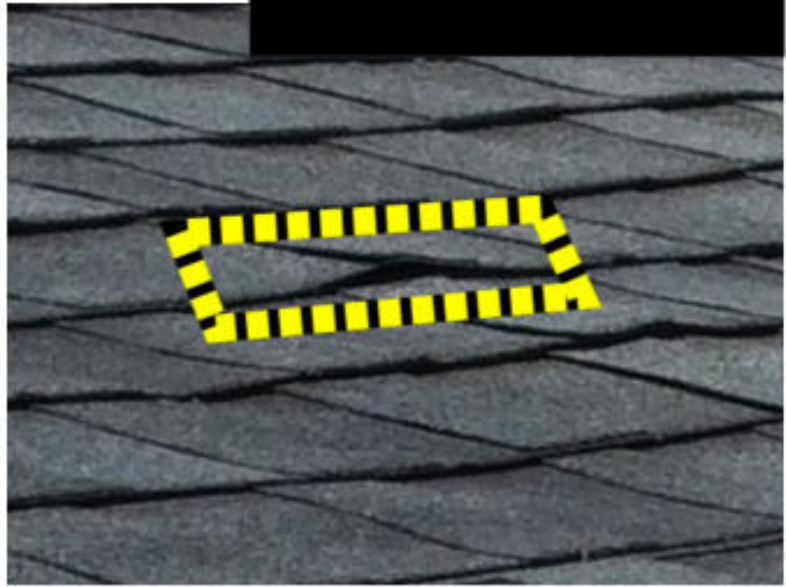
DETAILED VIEW - WIND #6

Damage consistent with wind stress; Bulked shingle

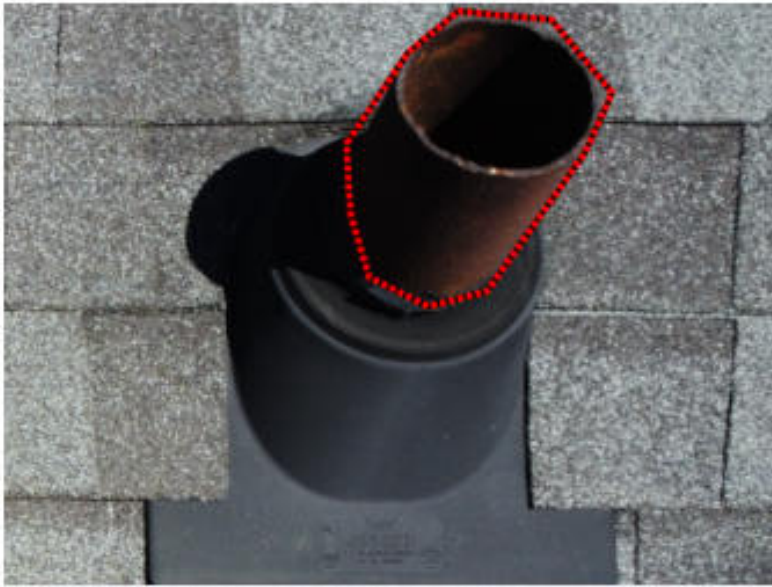
DETAILED VIEW - PENETRATIONS #1

Rusted vent

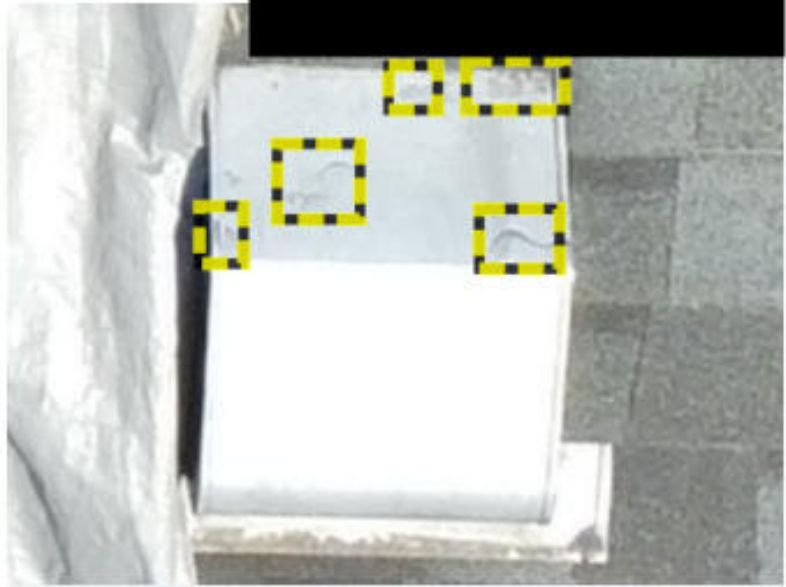
DETAILED VIEW - PENETRATIONS #2

Dented Vent

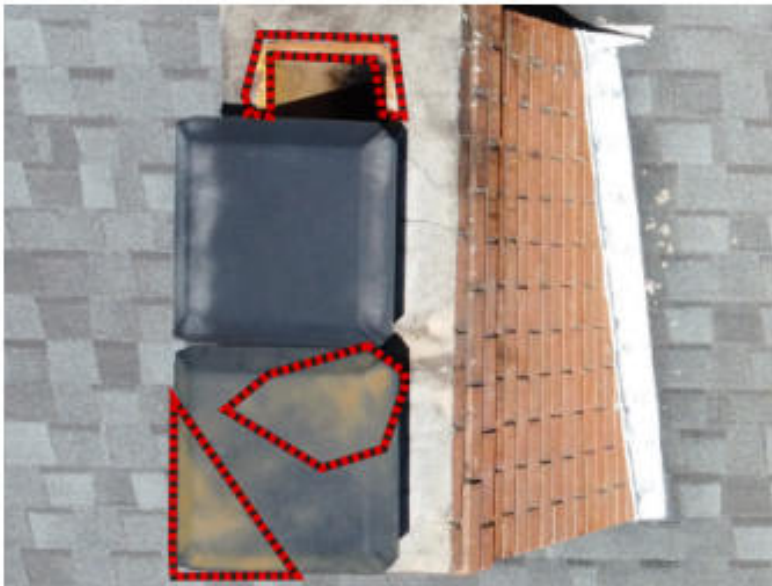
DETAILED VIEW - PENETRATIONS #3

Chimney crown rusted

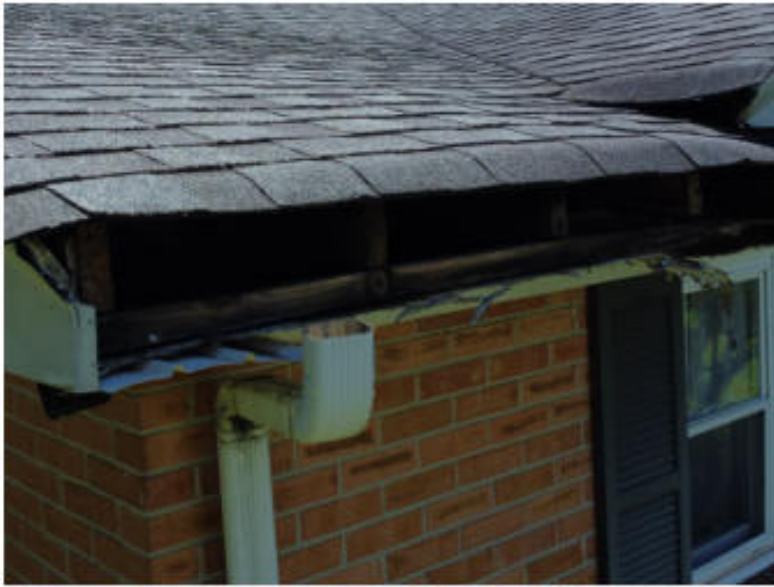
DETAILED VIEW - GUTTERS AND DOWNSPOUTS #1

Broken gutter

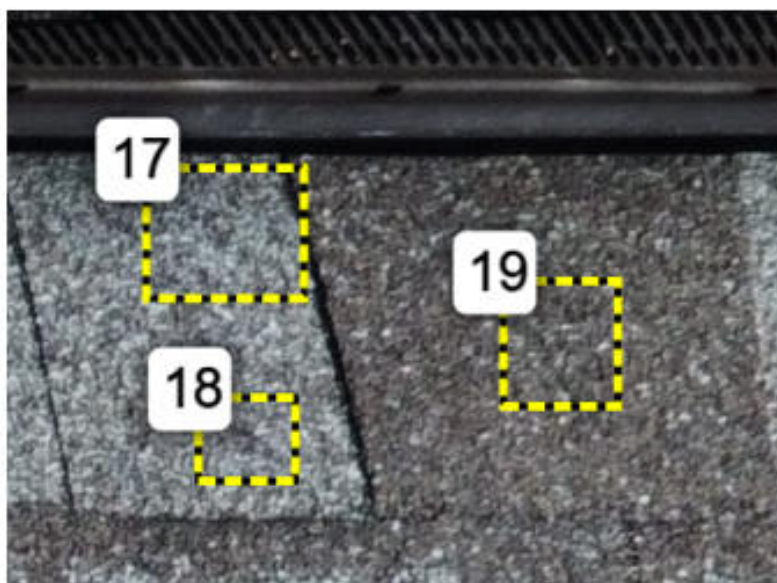
### SUB-AREA A

Multiple hail strikes; Granule loss

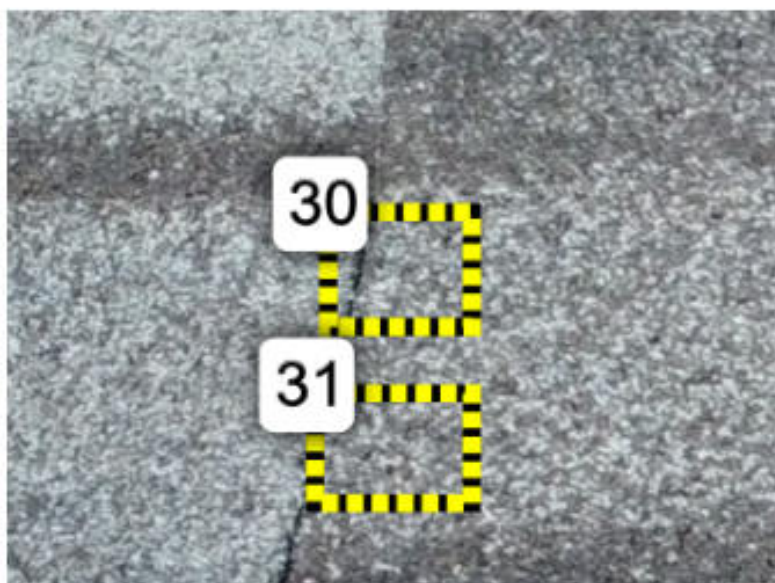
### SUB-AREA B

Granule loss

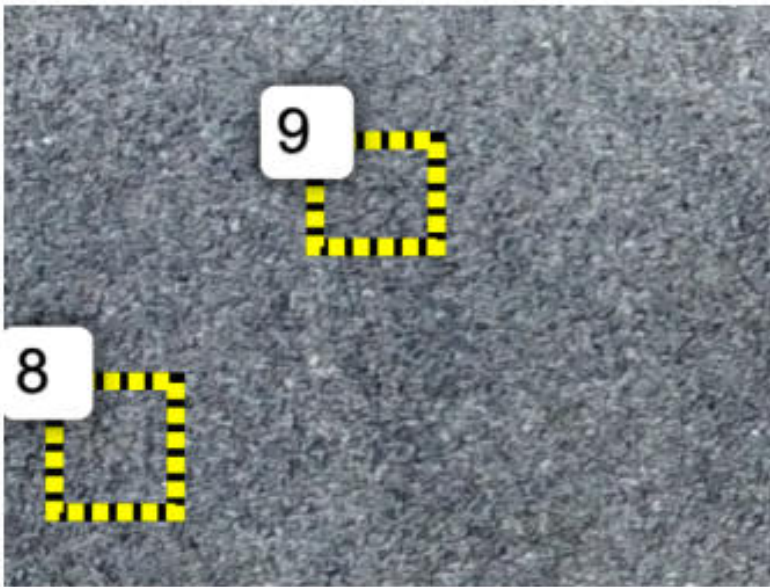
SUB-AREA C

Hail strike; Granule loss

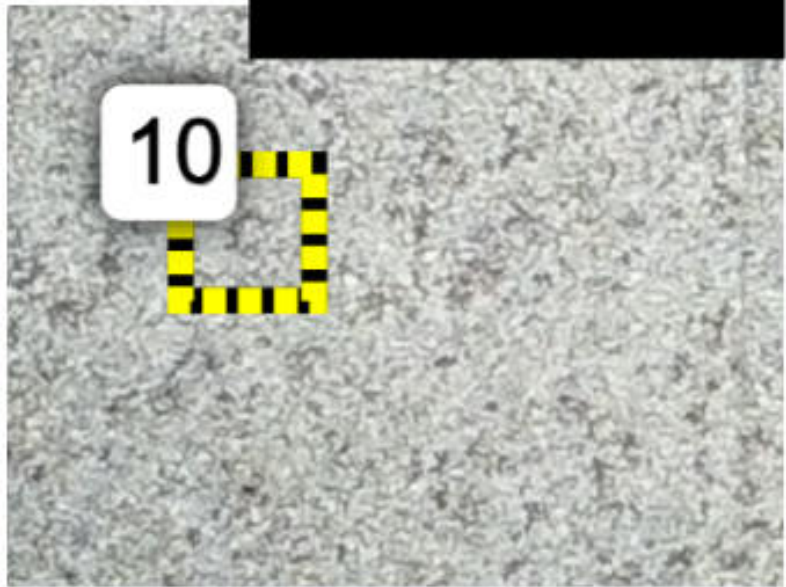
SUB-AREA D

Hail strike

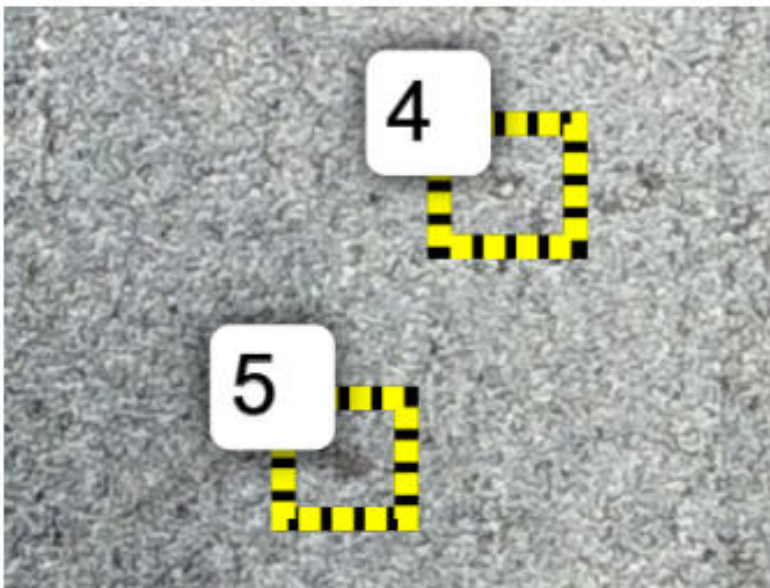
SUB-AREA E

Hail strike; Granule loss

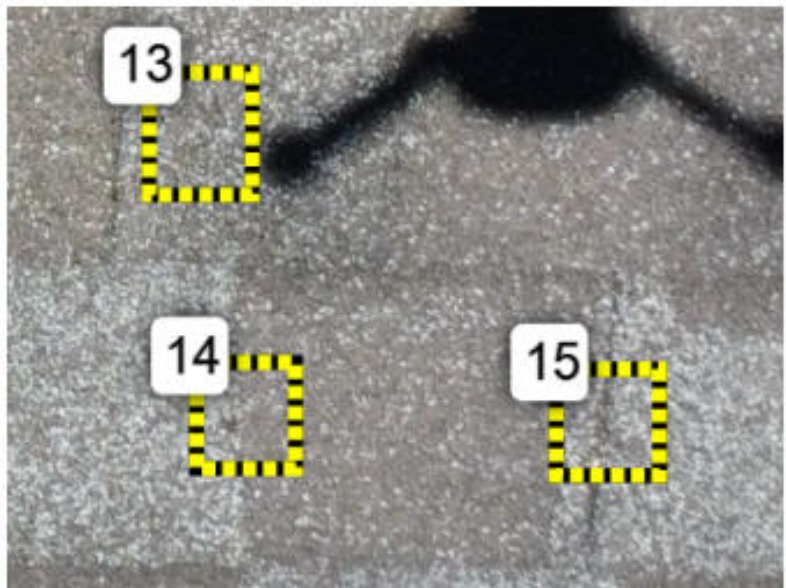
SUB-AREA F

Hail strike; Granule loss
